PROGRAM TITAN IIIM
STANDARD SPACE LAUNCH VEHICLE
DEVELOPMENT REPORT
FOR
STAGE I ENGINE DEMONSTRATION TESTING

Report 9180-941-DR-9

31 March 1969

Aerojet-General Corporation
Liquid Rocket Operations
Sacramento, California
95809

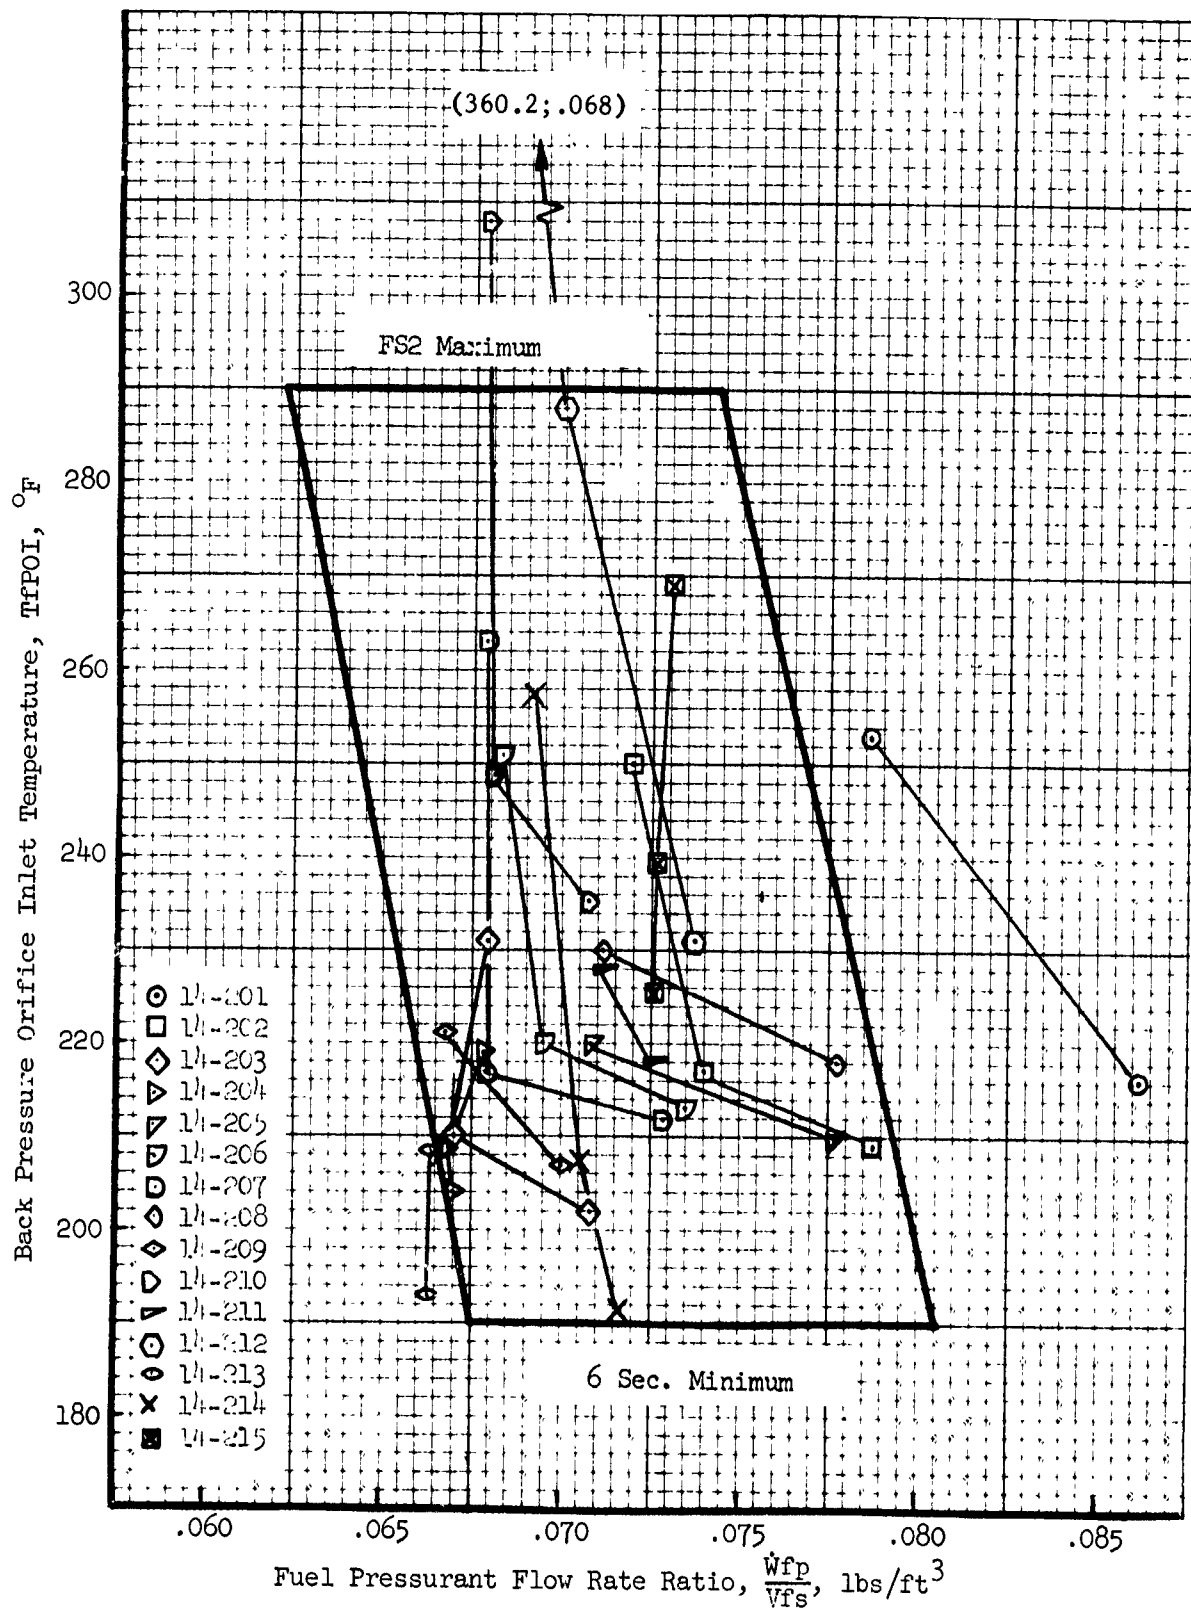
Figure 33 -- Fuel Autogenous Pressurization System Performance,
Engine S/N 14

Figures 33 and 34 show the fuel autogenous pressurization system performance for all the engine demonstration tests. In Figure 33, all the tests with engine S/N 14 were within the specification box limits with the following exceptions:

The data from Test No. -213 were outside the minimum flow limit because of the low thrust, peripheral test conditions. On the succeeding test, thrust was increased nearer to rated thrust and the autogenous flow also increased to within specification limits.

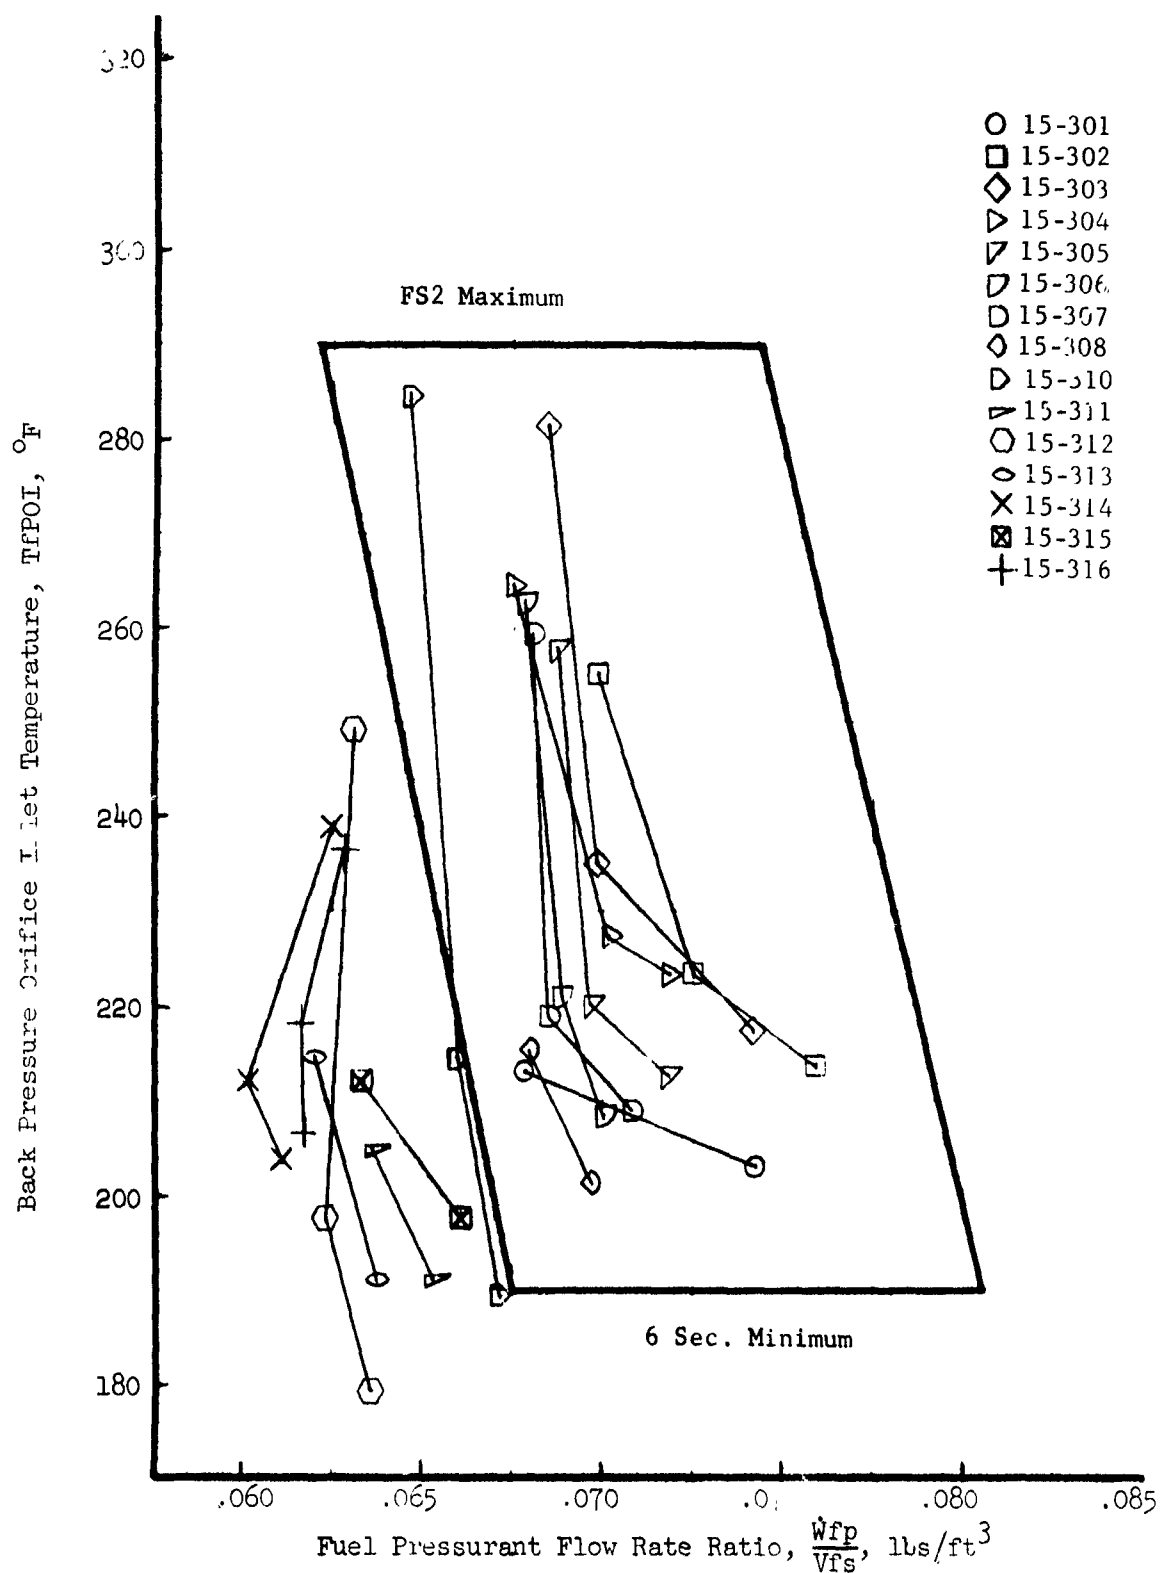
Figure 34 -- Fuel Autogenous Pressurization System Performance, Engine S/N 15

In Figure 34 the data from the performance evaluation with engine S/N 15, Test Nos. -302 through -306, were within the box limits. The data from some of the peripheral tests were outside the limits, and show a larger scatter when compared to the engine S/N 14 tests (Figure 33), because the engine S/N 15 was tested under more severe peripheral conditions of thrust and mixture ratio.

Of particular interest is the effect of 90° propellant inlet temperature, resulting in a larger increase in T_{fp0i} at the FS2 point. Test No. -310 in Figure 34 ranged the full distance between minimum and maximum box temperature limits.

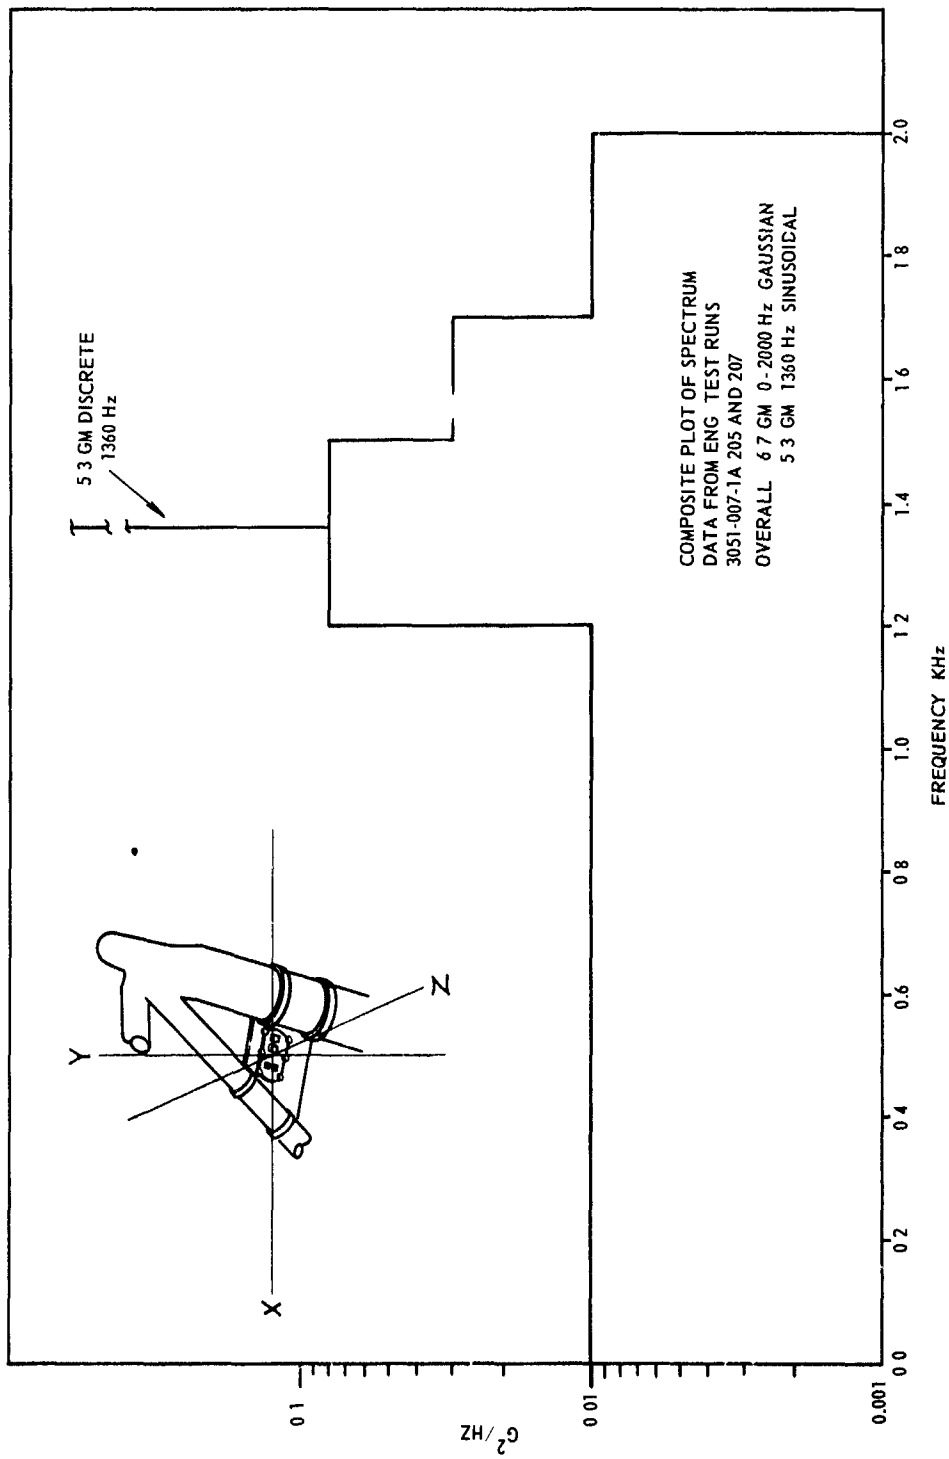
Figure 38 -- Vibration Environment -- Redundant Interface J-Box

Knowledge of the vibration environment of the redundant interface J-box was desired since the J-box is a redesigned version of the existing Titan engine controls harness interface box. Redesign was necessary to meet the circuit isolation requirements of SSD-CR-65-8180-150, Electromagnetic Compatibility (EMC) Control Plan, and to add transient suppression diodes across the pressure sequence valve override solenoid (PSVOR). The new redundant interface J-box is a modification of the interconnection box used with the Titan engines instrumentation kits. The instrumentation kit interconnecting box is designed to withstand a vibration environment of 43g rms, combined sinusoidal and random.

It is concluded from the low vibration profile of Figure 38 (approximately 6.7g rms Gaussian combined with 5.3g rms sinusoidal at 1360 Hz) that a considerable design safety margin exists for the redundant interface J-box.

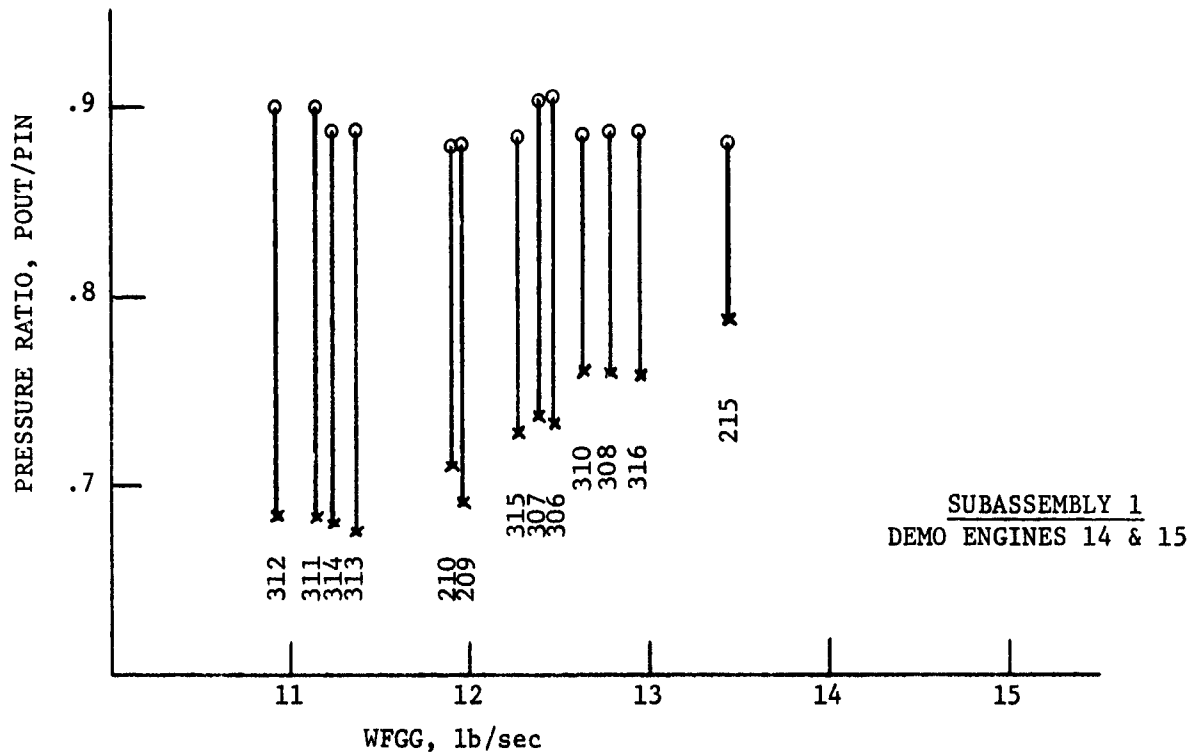
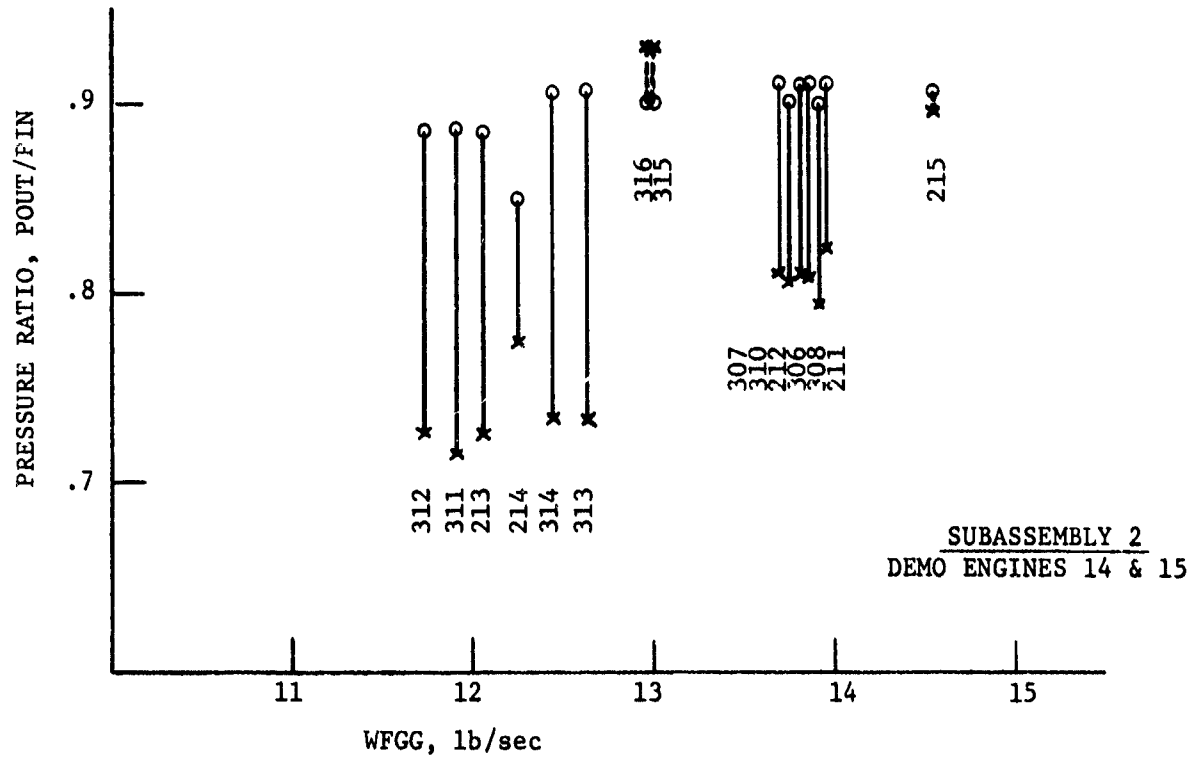
Figure 39 -- Fuel Venturi Suppression Ratios
 Titan IIIM Demo Tests

In Figure 39 the actual venturi pressure ratios and the suppression points are plotted vs the fuel flow rates, WFGG, for all the tests with PFCKV instrumented, plus Test No. -208. The connecting vertical lines in the figure indicate the margin of cavitation, and illustrate how the margin decreases with the increased demand for WFGG, which is proportional to turbine horsepower requirements. The two tests, Nos. -315 and -316, with artificially suppressed cavitation, are shown at a value on the abscissa of 13 lb/sec (WFGG), which was estimated by using the pressure drop across the gas generator fuel injector and the average resistance as derived from other tests with this injector where the flow rate was known.

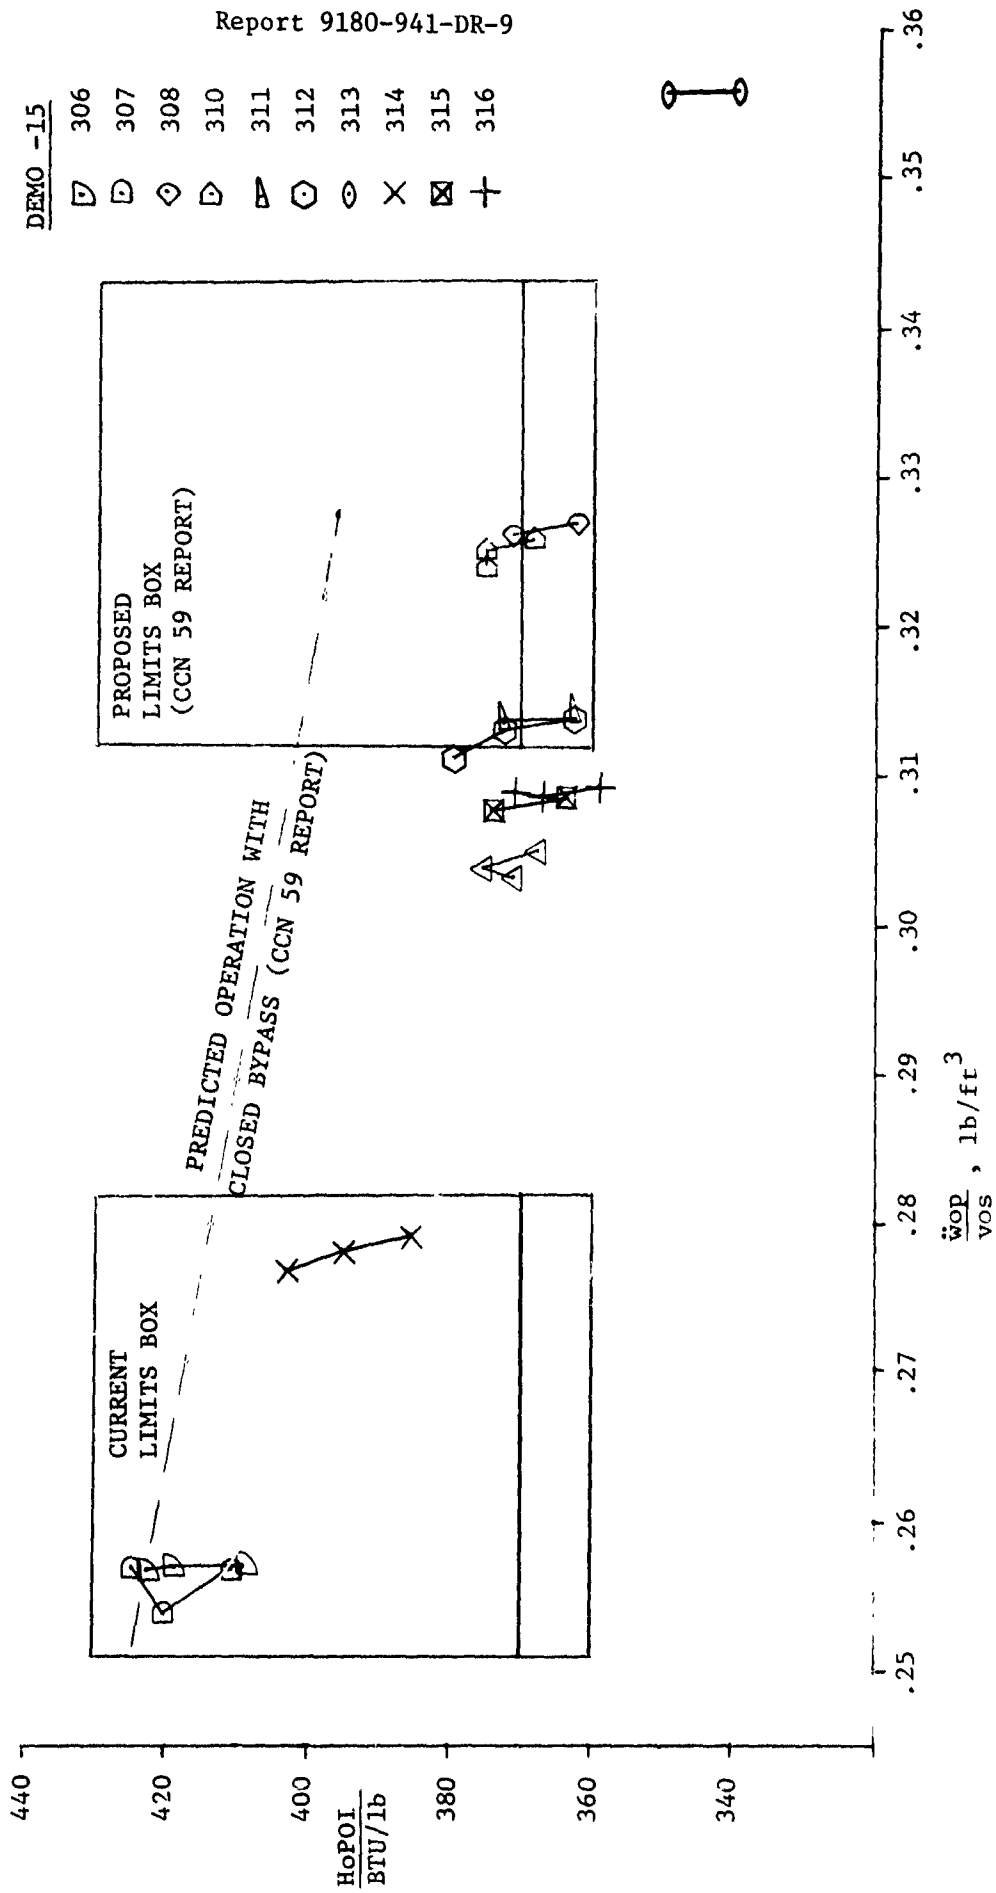
Figure 40 -- Oxidizer Autogenous Increased Flow Tests

All the special autogenous tests are shown in Figure 40. They include ten tests with engine S/N 15 and the final test with engine S/N 14. The tests were conducted with the superheater bypass lines blanked off to attain maximum enthalpy. Two base tests, Nos. -305 and -306, were conducted at nominal flow (WOP/VOS). The flow was then increased for a number of tests, using three large venturis (KOPV). The venturi size was reduced to an intermediate value for Test No. -314.

The dashed line in Figure 40 indicates the expected enthalpy vs flow characteristic for closed bypass operation, as predicted in the CCN 59 report. It can be seen that the tested values of enthalpy dropped off at a higher rate than expected.

It should be noted that the increased flow tests were also in conjunction with the engine demonstration peripheral tests, and therefore, to compare the various points, the enthalpy and flow values in Figure 40 should be normalized for nominal thrust, mixture ratio and propellant temperature. This was to have been part of the now discontinued analysis effort, but it is apparent that even with this correction of the data, the enthalpy would still be lower than predicted.

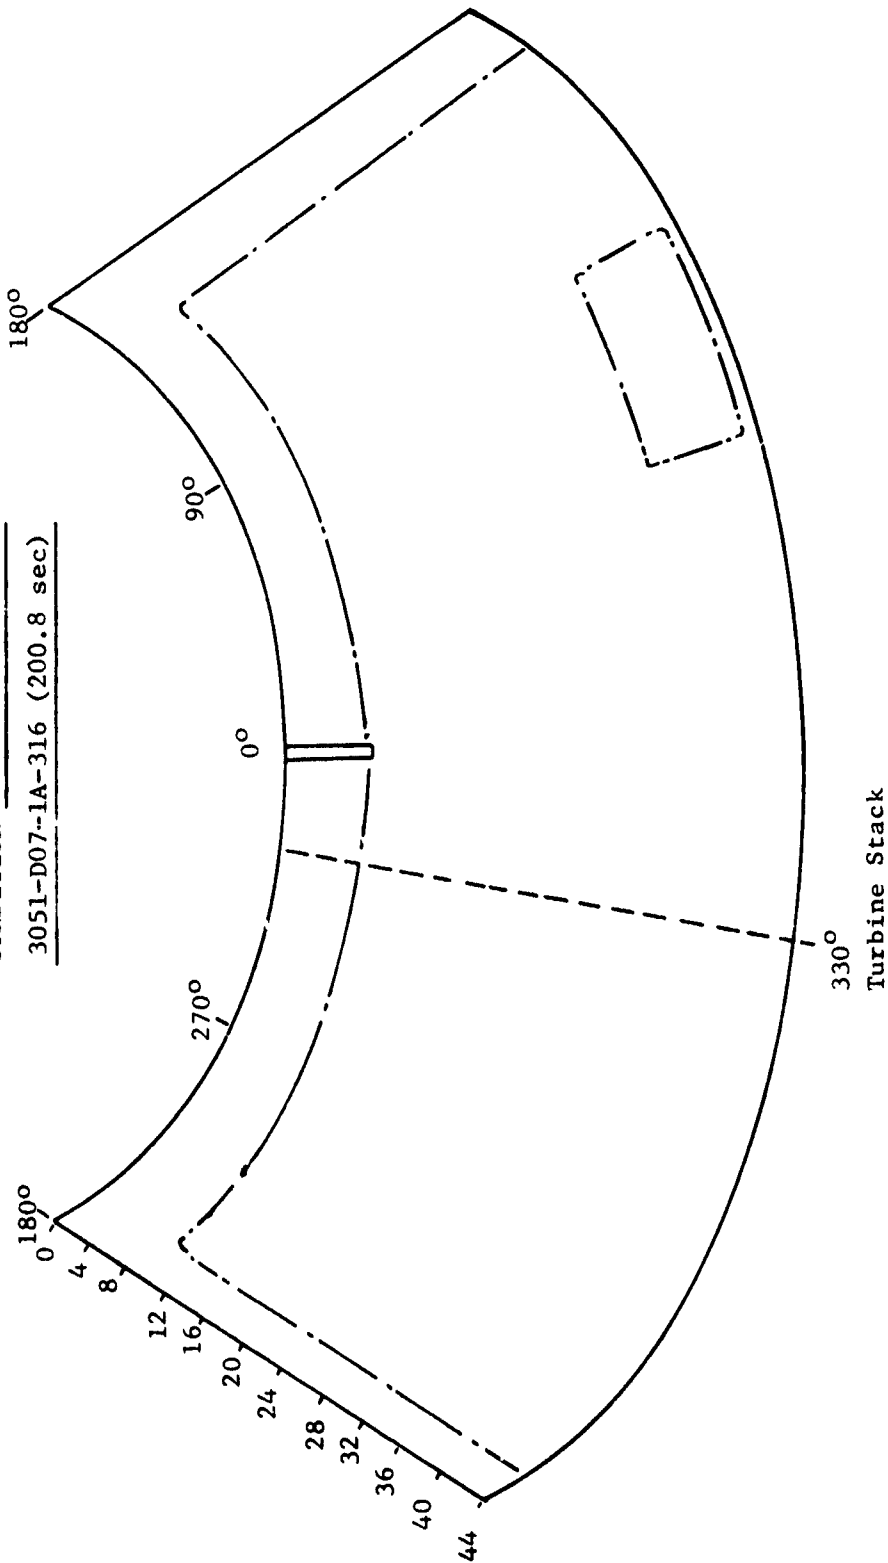
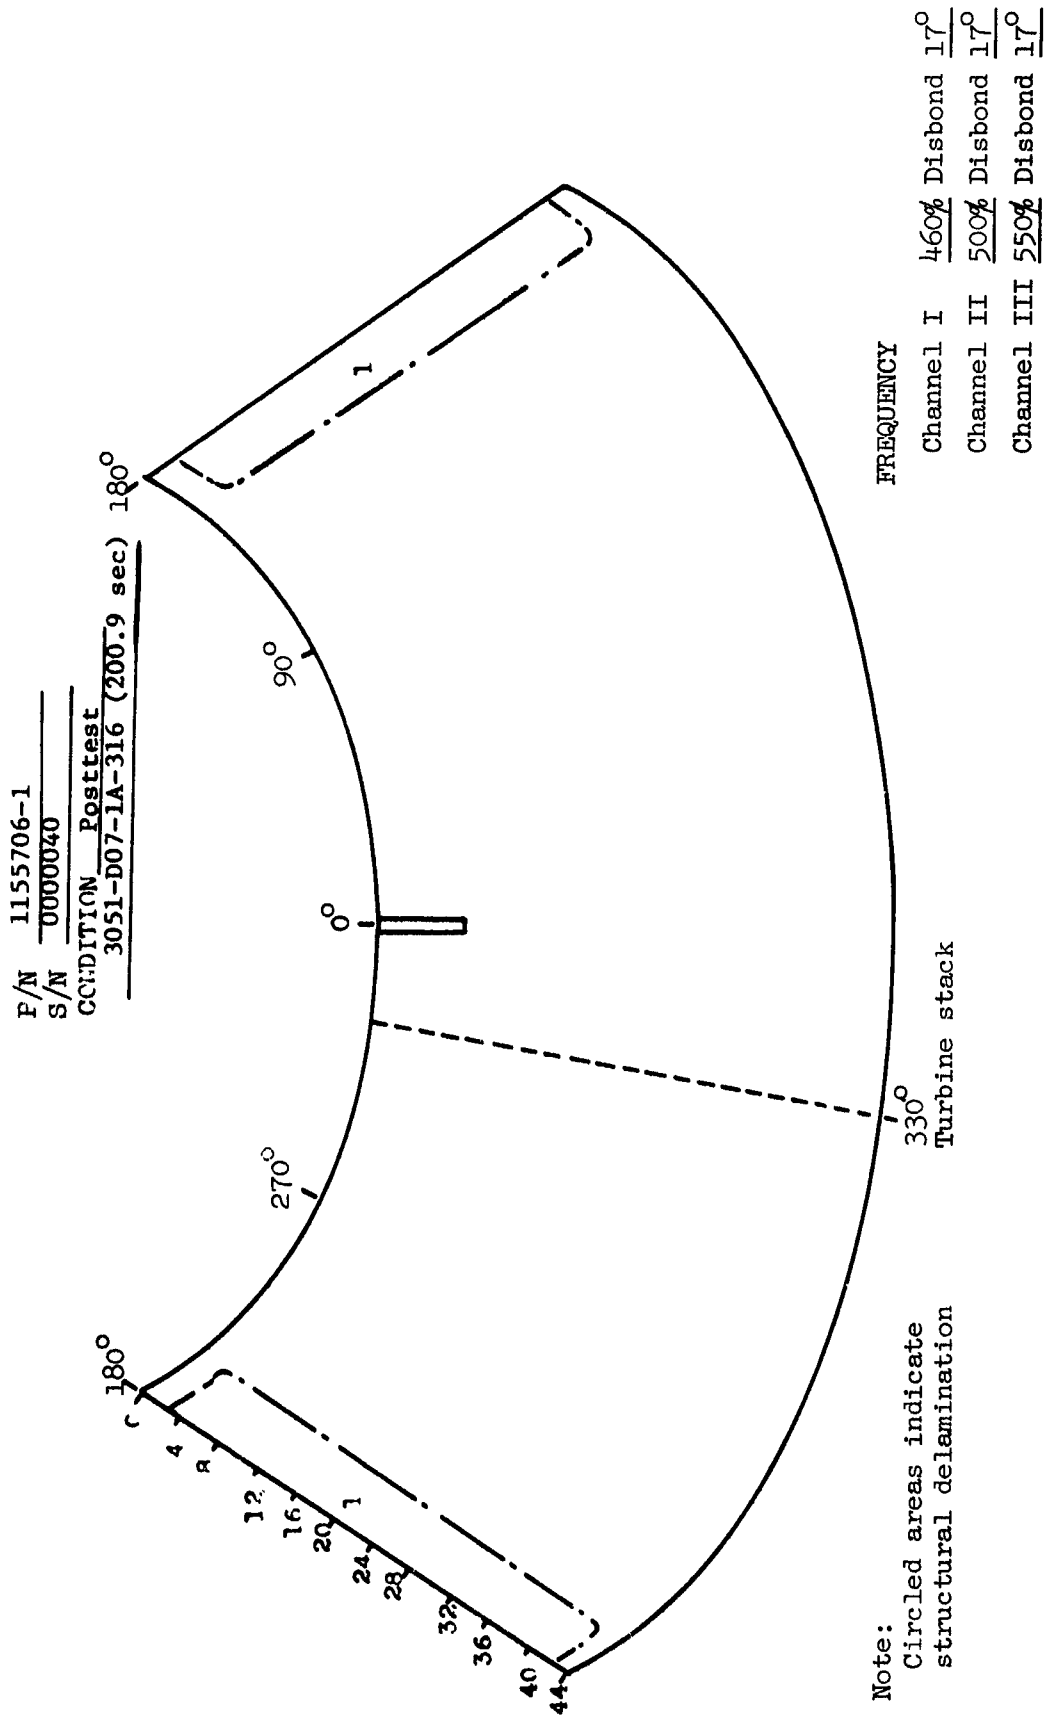
Figure 44 -- Sonic Tap Test, Skirt 040

Circled areas indicate
Structural Delamination

Channel I	3K-8K%	Disbond	-
Channel II	4K-6K%	Disbond	-
Channel III	3.8K-4K	Disbond	-

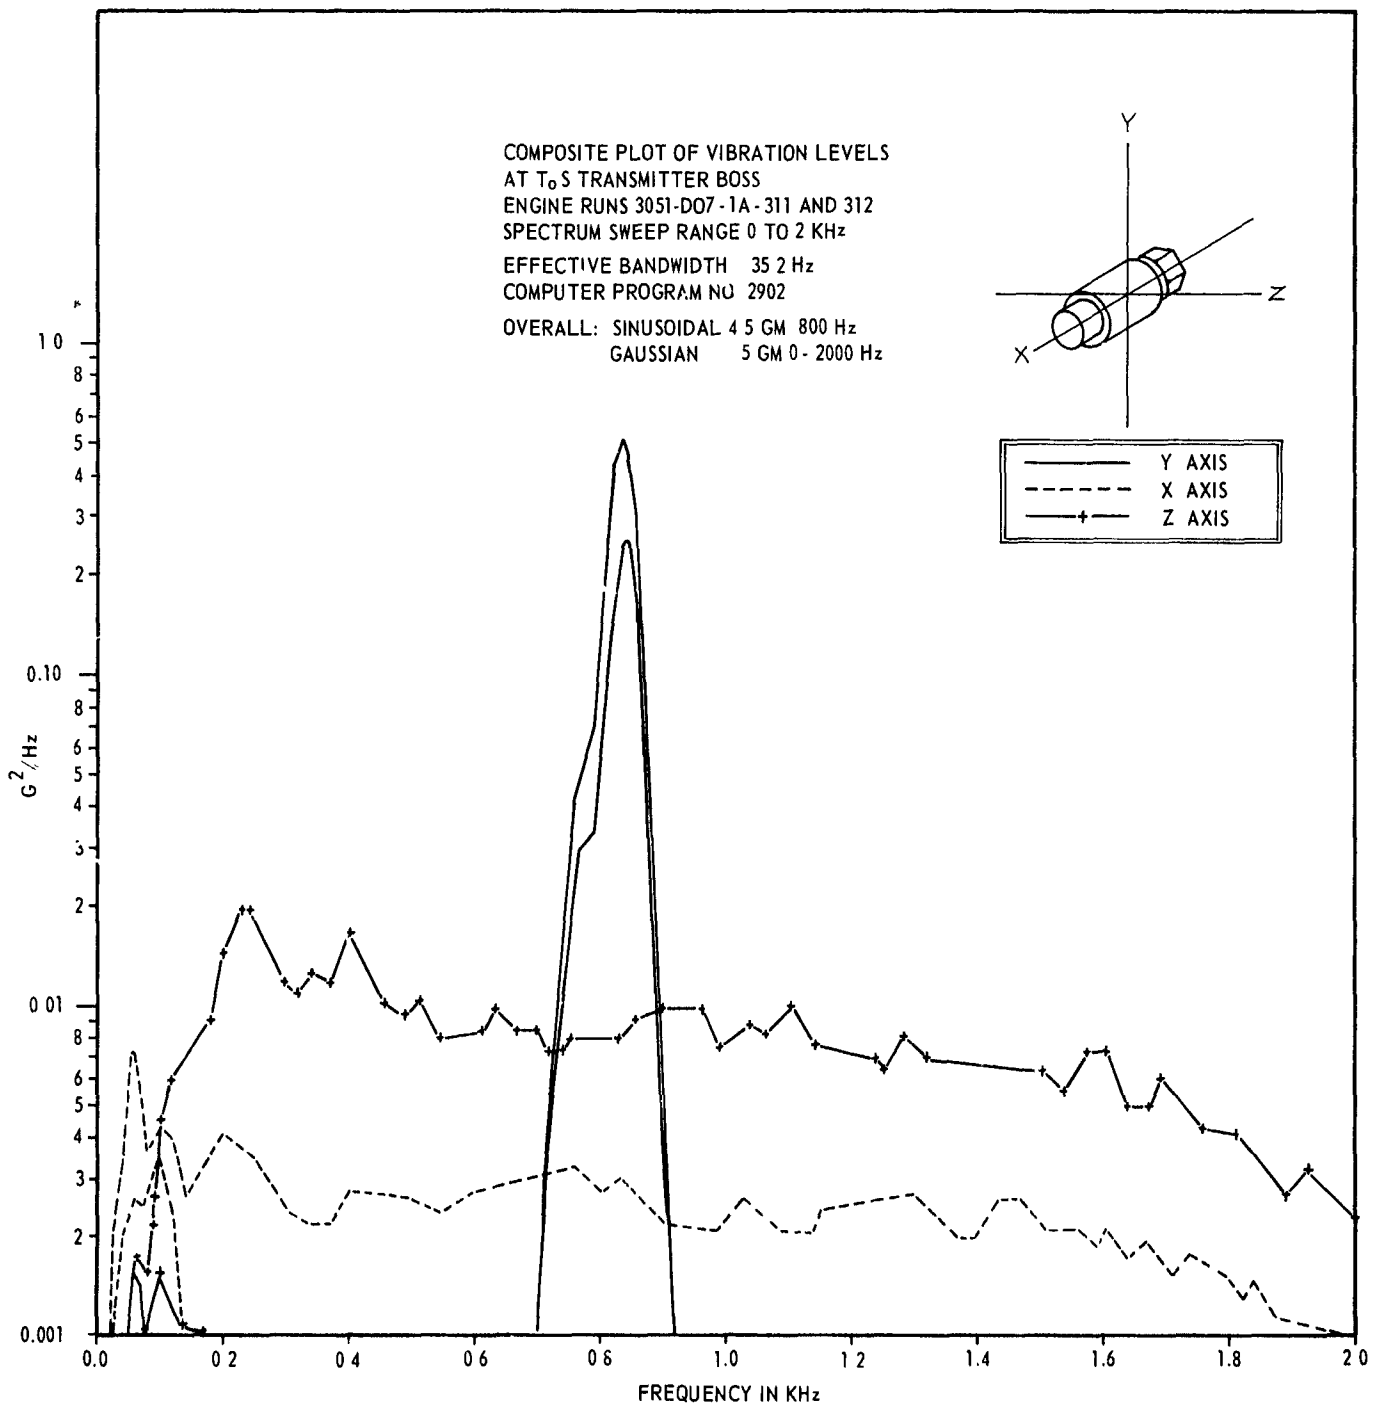
Figure 52 -- Vibration Levels, Tos Transmitter Boss

Three single-axis accelerometers were installed adjacent to the T_{os} and T_{fs} temperature transmitter bosses on the suction spools for several engine test runs. Figure 52 and Figure 53 are composite plots of the power spectral density computed for each axis at the T_{os} and T_{fs} locations, respectively. The vibration profile for the T_{os} location is based on data

Both Figures 52 and 53 indicate vibration levels of less than one-half the acceptance vibration levels for the temperature transmitters (approximately 22g rms, combined sinusoidal and random).

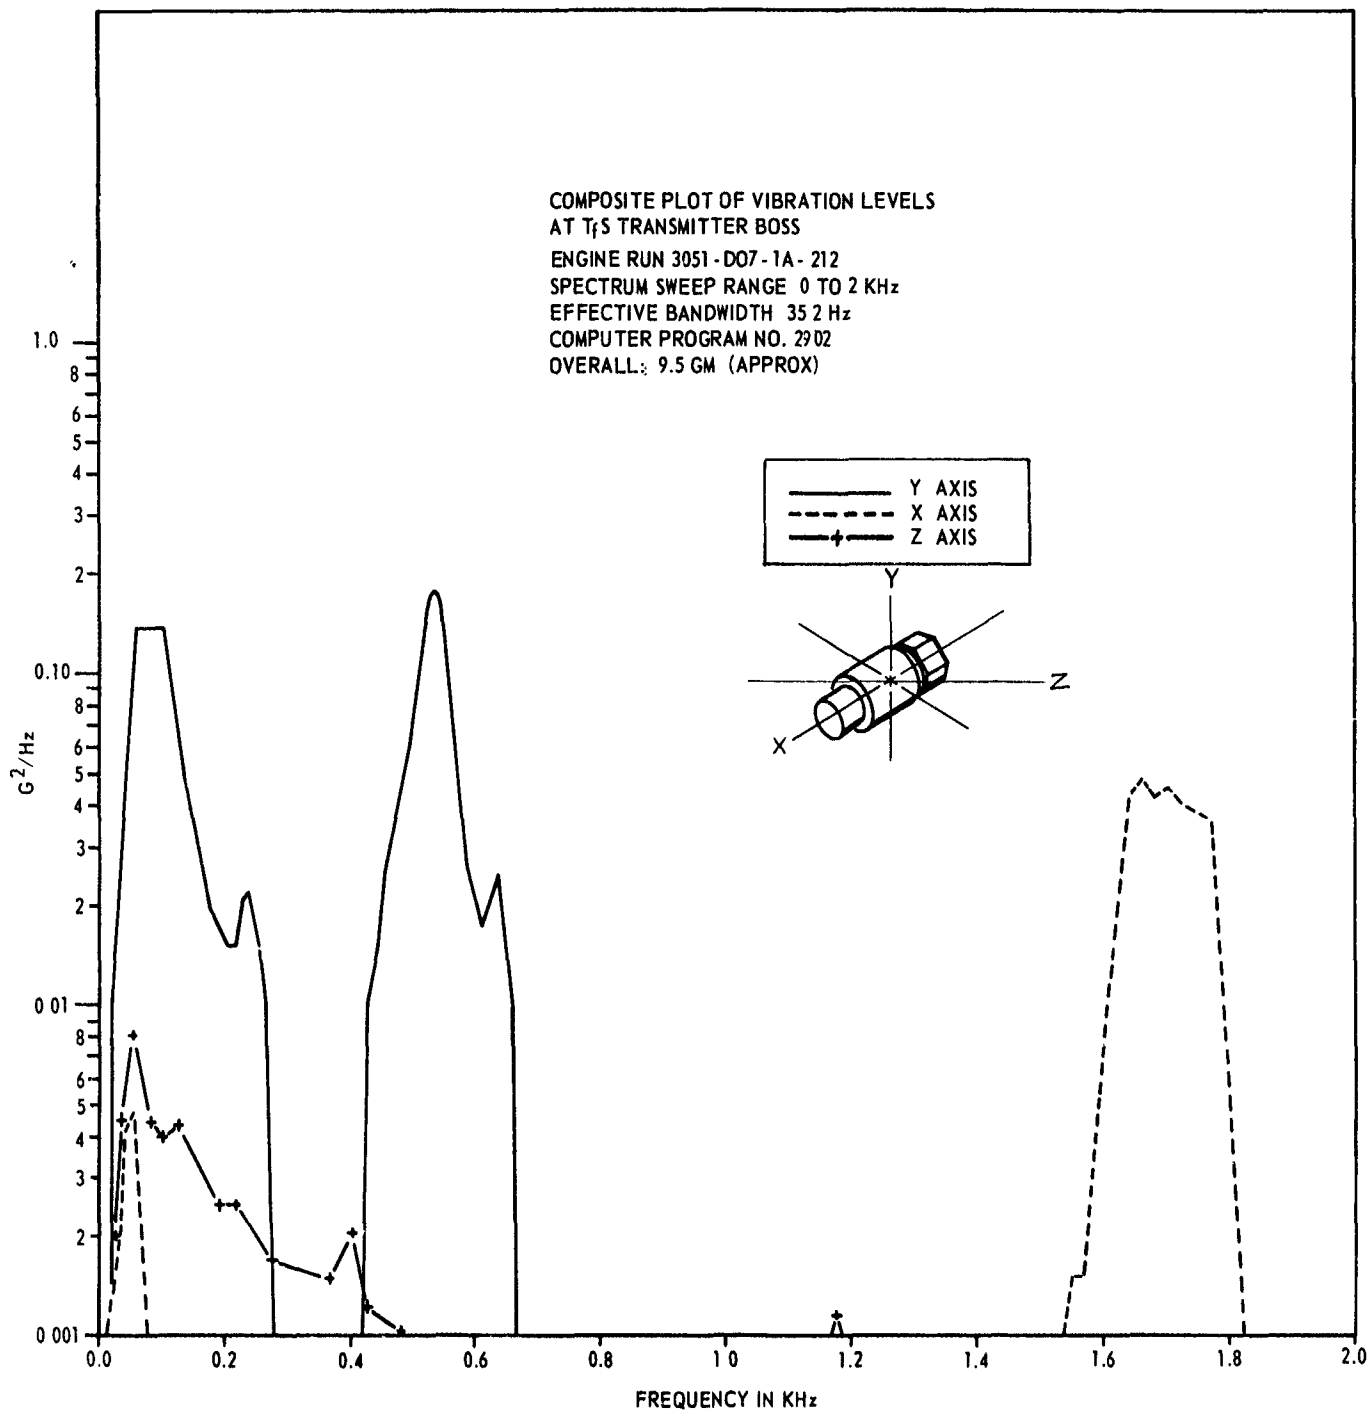
Figure 53 -- Vibration Levels, T_fs Transmitter Boss

from two engine tests. The spectrum is defined as approximately 5g rms, 0 - 2000 Hz Gaussian in combination with a discrete sinusoidal level of 4.5g rms at 800 Hz. The profile for T_{fs} is based on data from one test and shows a spotty energy distribution of significance in the X and Y axis only. The overall 9.5g rms of Figure 53 is the resultant sum of the X and Y axis levels.

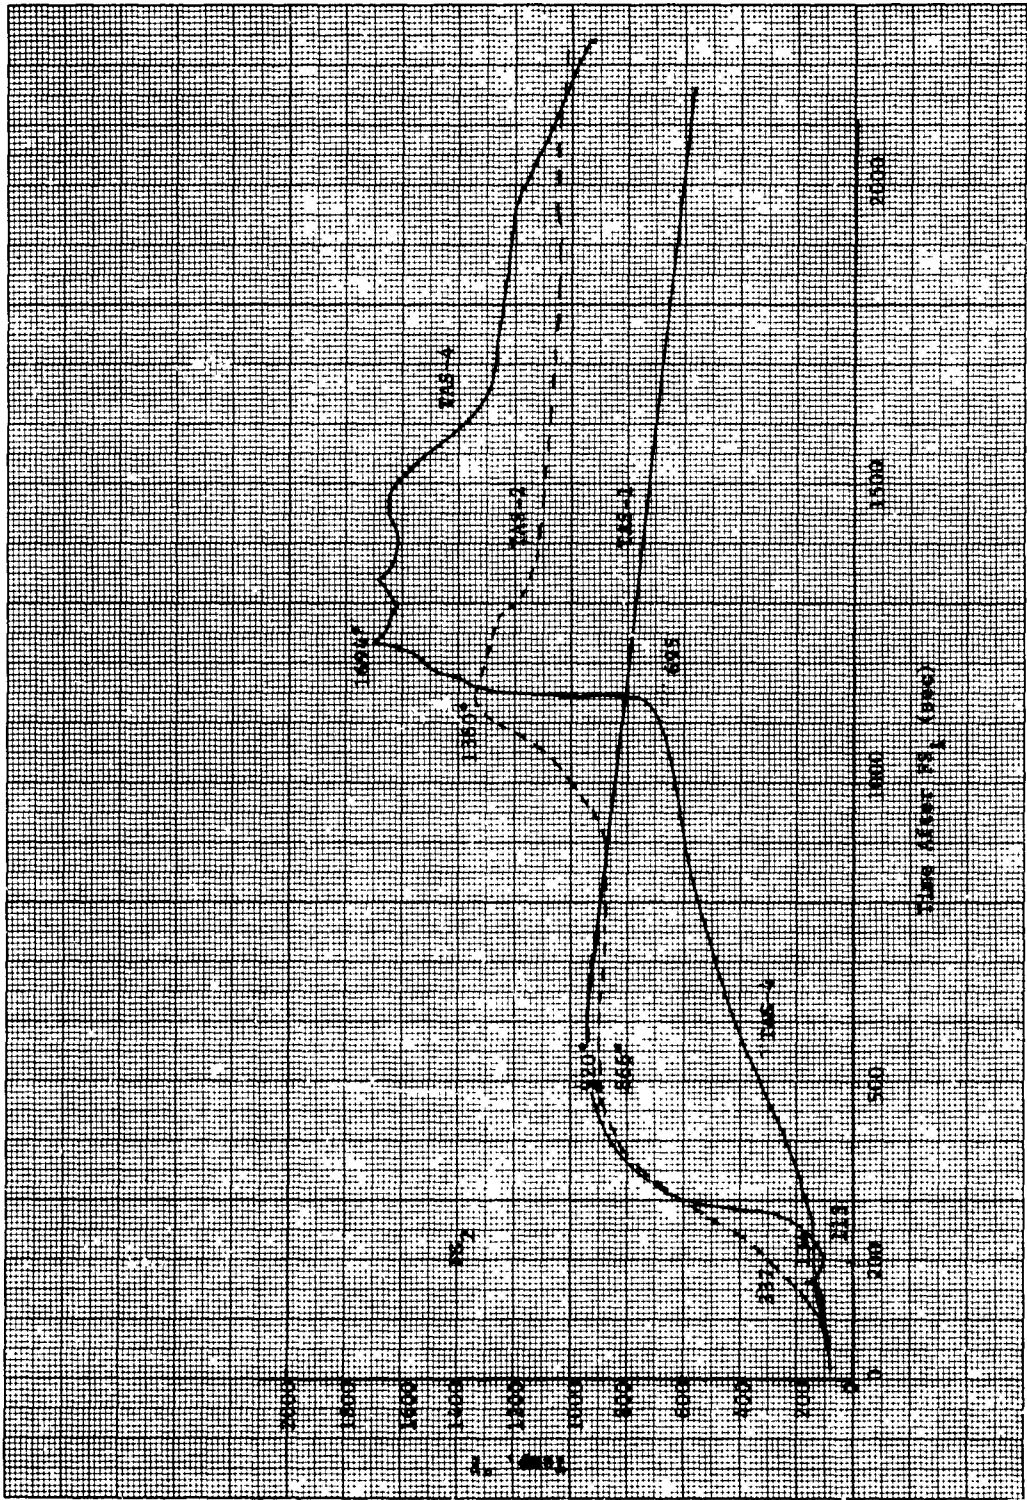
Figure 60 -- Liner and Outer Laminate Temperatures -- Ablative Skirt S/N 003

The location of the thermocouples is shown in Figure 59. The temperature plots obtained for skirts S/N 003 and S/N 005 are presented in Figures 60 and 61, respectively.

Although the two skirts performed satisfactorily, as indicated, both units were severely damaged by postfire burning which became most pronounced, producing the severest temperatures (1600°F-1700°F), at FS2 + 900 sec on Subassembly 2 and at FS2 + 1300 sec on Subassembly 1. The area of greatest damage was sustained at the point located under the turbine exhaust stacks. In these areas the resin was completely removed with no ash remaining, indicating that the necessary oxygen to produce this result was available. Pictures of the damaged units are presented in Figure 62. Figure 63 shows the skirts (postfire) mounted on the engine, including the refrasil covers. Figure 62 is an enlargement of the damaged area on both skirts, while views 62b and 62c show the details of the fire damage to skirts S/N 003 and S/N 005, respectively.

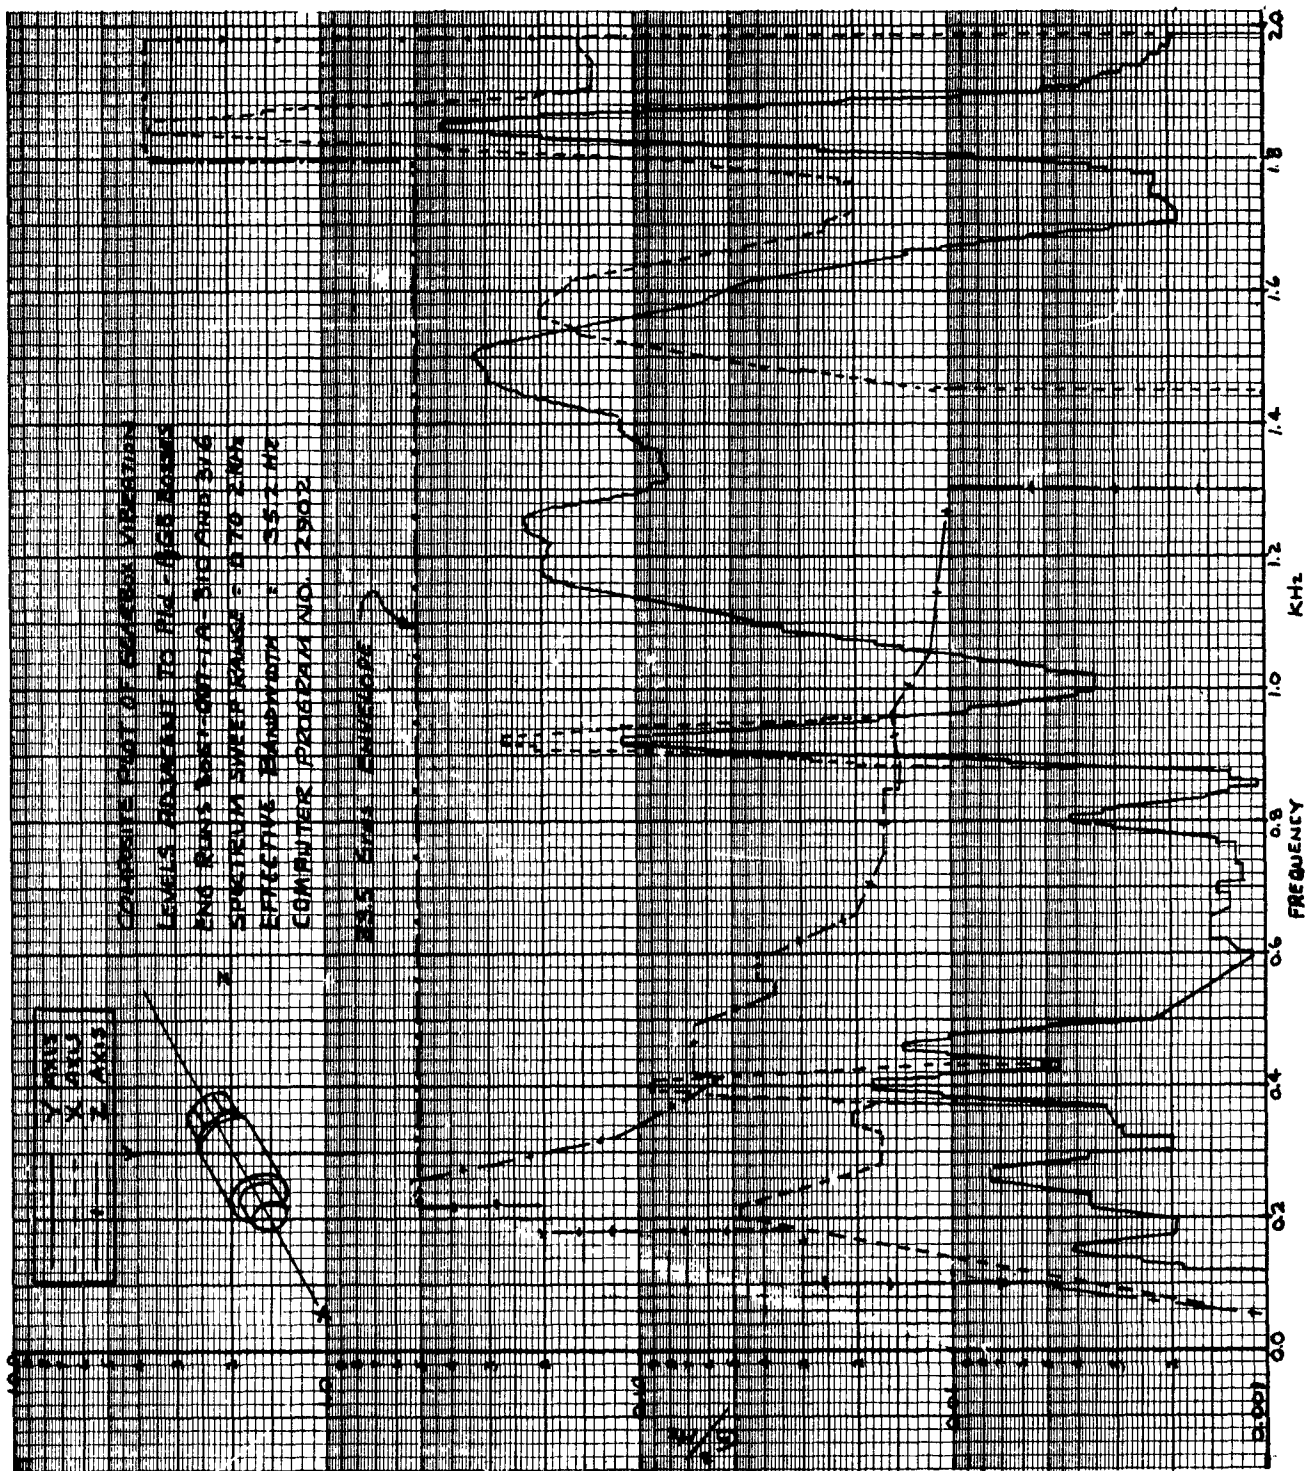
Figure 64 -- Gearbox Vibration Levels -- P_{1d} and P_{GB} Locations

Three single-axis accelerometers were installed on engine Subassembly 1 at points between and equidistant from the Pld and PgGB pressure ports, and data were recorded from five engine tests. PSD plots were calculated for two of these tests and the results are shown in the composite plot. Figure 64 shows the maximum energy levels for each axis obtained for the two runs. A PSD maximum envelope is plotted and the corresponding overall g rms approximated for comparison purposes. The 33.5 g rms overall level shown in Figure 64 is notably less than the Stage I engine mounted equipment level (48.8 g rms) of SS-TIIM, Figures 3 -20, in accordance with which the CEC transmitter was tested during component qualification testing.

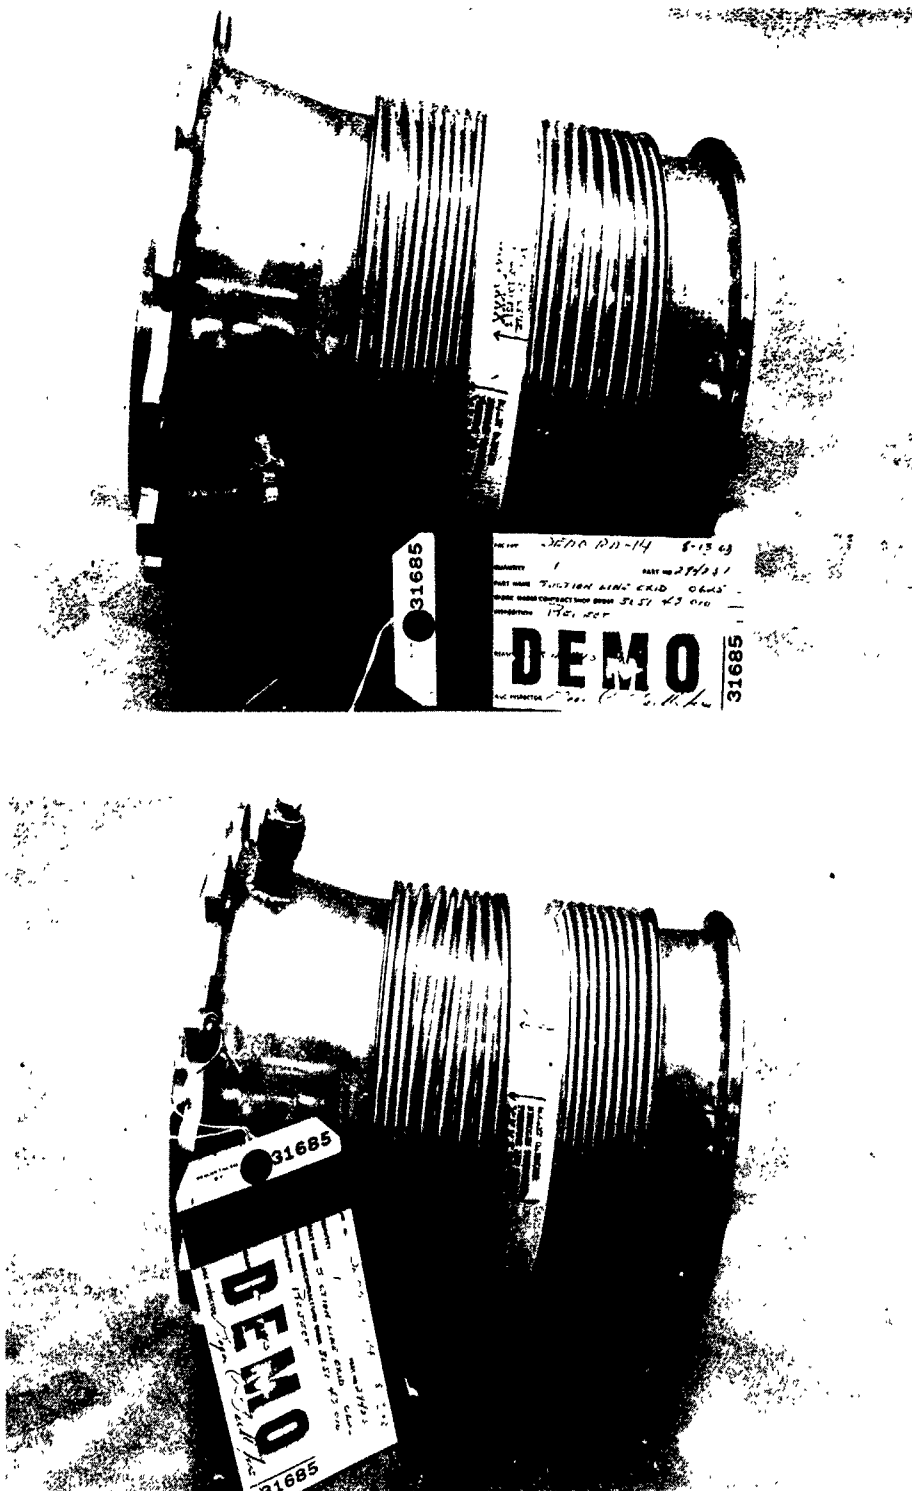
Figure 66 -- Oxidizer Suction Line S/N 625

Excessive bellows distortion was observed on oxidizer suction line S/N 625 after Test No. -214 (see Figure 66). The line had been subjected to 1624 seconds of engine testing while installed on engine S/N 14, Subassembly 1. Oxidizer suction line S/N 628, which replaced S/N 625, was also found to have excessive distortion (See Figure 67). One 200 second test had been conducted with this line installed. The degree of distortion appeared to be similar in both cases. Subsequent to completion of demonstration testing the oxidizer suction lines on both subassemblies of engine S/N 15 and the line installed on Subassembly 2 of engine S/N 14 were found to have normal amount of distortion.

Oxidizer suction pressure spikes and engine interface alignment were reviewed to determine the cause of the discrepancies. The review disclosed that the maximum suction pressure spikes during tests No. -214 and No. -215 were lower in magnitude (395 psia and 410 psia respectively)

It is concluded that the distorted suction lines noted on engine S/N 14 were the result of engine-to-test stand misalignment.
